THAMES RIVER BASIN  
GRISWOLD, CONNECTICUT

STONE HILL RESERVOIR DAM  
CT 00436

PHASE 1 INSPECTION REPORT  
NATIONAL DAM INSPECTION PROGRAM

MAY 1979

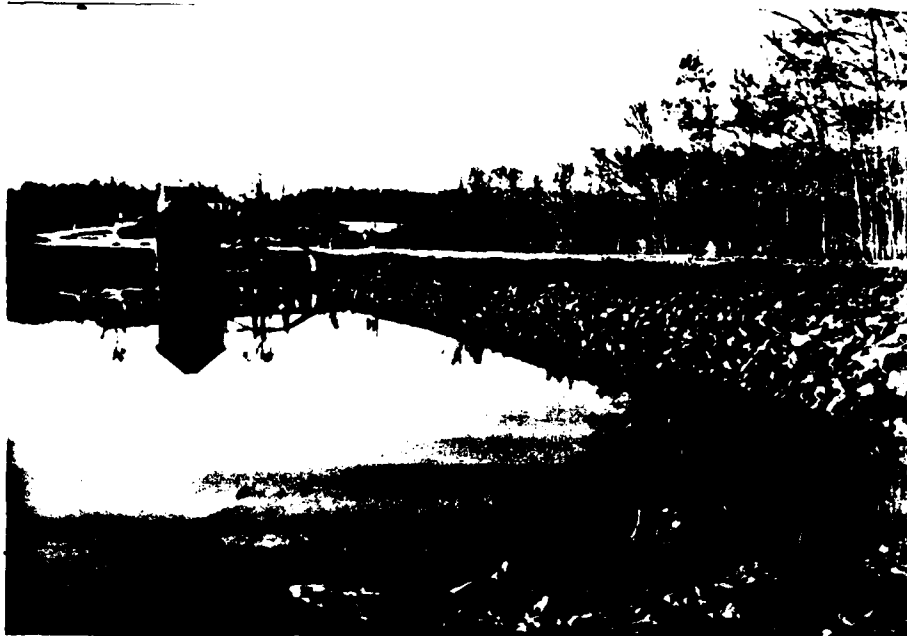
2. Upstream Slope. The upstream slope is partially covered with riprap as shown in Photos C-1,2, and in the sketches (Appendix B). The riprap ranges from six inches to three feet in size. The riprap is in good condition with only a few windows evident. No grass is growing on this section of the slope.

C-1 UPSTREAM EMBANKMENT SLOPE - LOOKING FROM RIGHT ABUTMENT.

- d. The riprap protection on the upstream slope should be restored and new stone armor placed up to the top of the dam.
- e. Evaluate the condition of spillway surfaces, structural condition and the procedure for installation of flashboards.

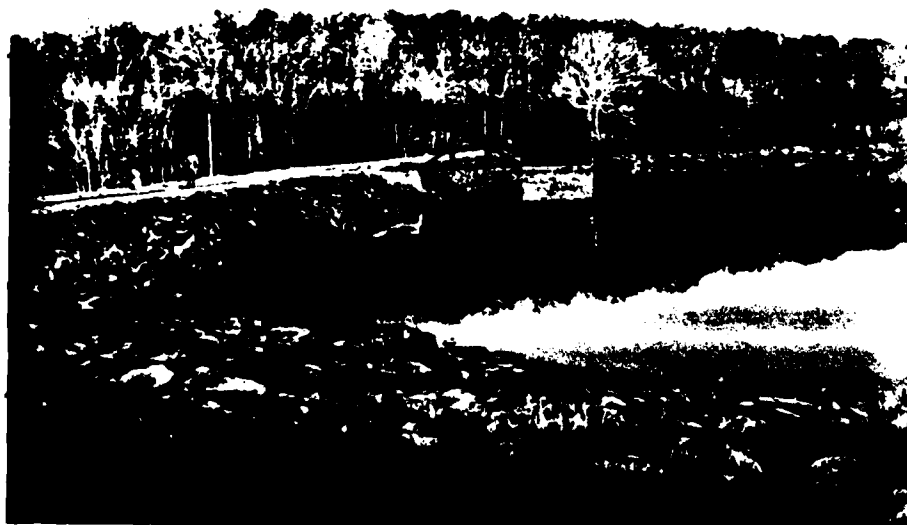
C-2 UPSTREAM EMBANKMENT SLOPE - LOOKING FROM LEFT ABUTMENT

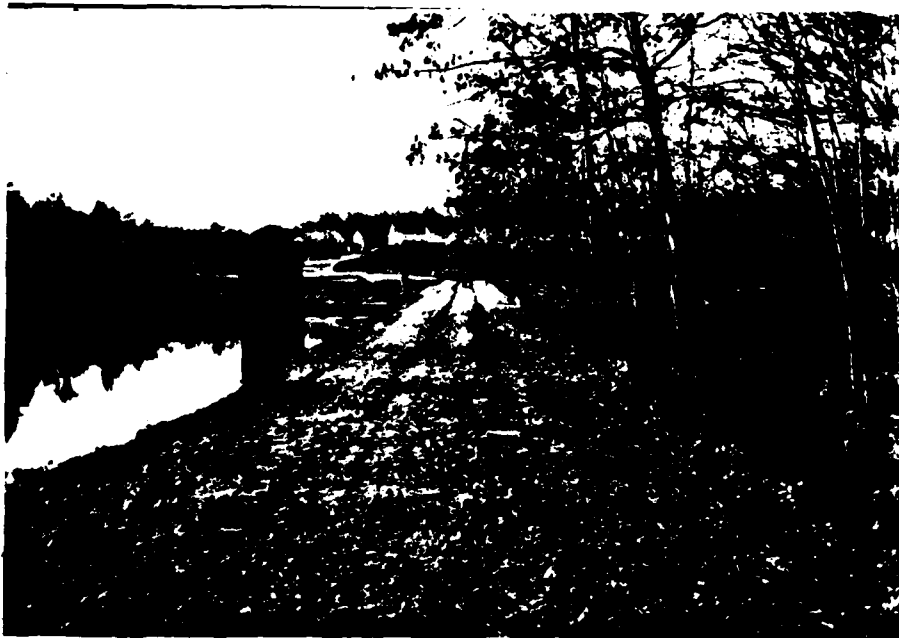
1. Crest. The crest of the dam is covered with grass, as shown in Photo C-3. The upstream edge of the crest lies at an elevation about six inches lower than the downstream edge. There are two five-inch deep ruts along the axis of the dam caused by vehicles trespassing across the crest. Along the downstream edge of the crest, there are two power

line poles. There is a slight settlement of the crest observed in the vicinity of station 3+50. Reference stationing is indicated on the Photo Index Sheet in Appendix C.

C-3 CREST OF MAIN EMBANKMENT.

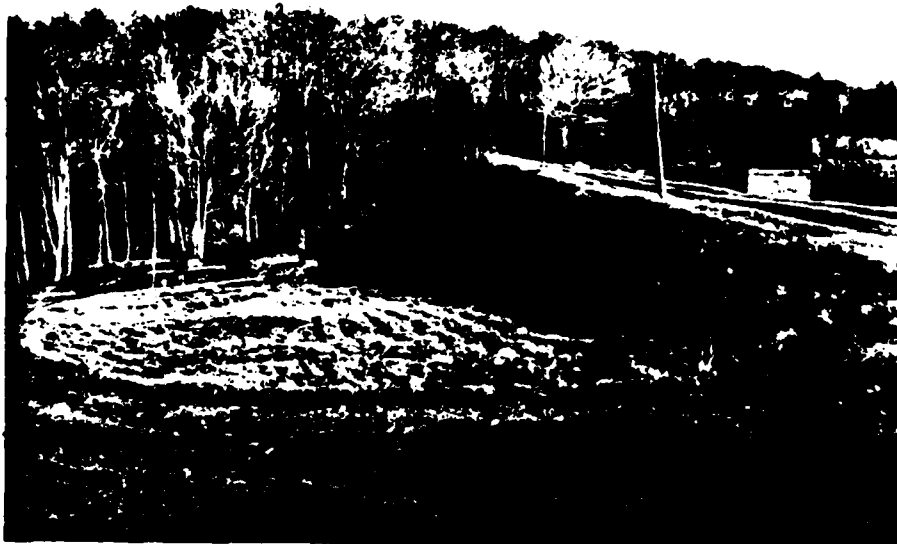
Trees and shrubs on the downstream slope of the embankment can create future seepage problems. The tree roots, if allowed to grow, provide seepage paths for water. Uprooting of large trees in storms can also cause serious "piping" problems by creating pathways through the embankments.

C-4 DOWNSTREAM SLOPE OF MAIN EMBANKMENT.

In view of the overgrown condition of the right embankment, it is important that the Owner institute a program of tree and root removal and trimming of vegetative growth before the trees become excessively large.

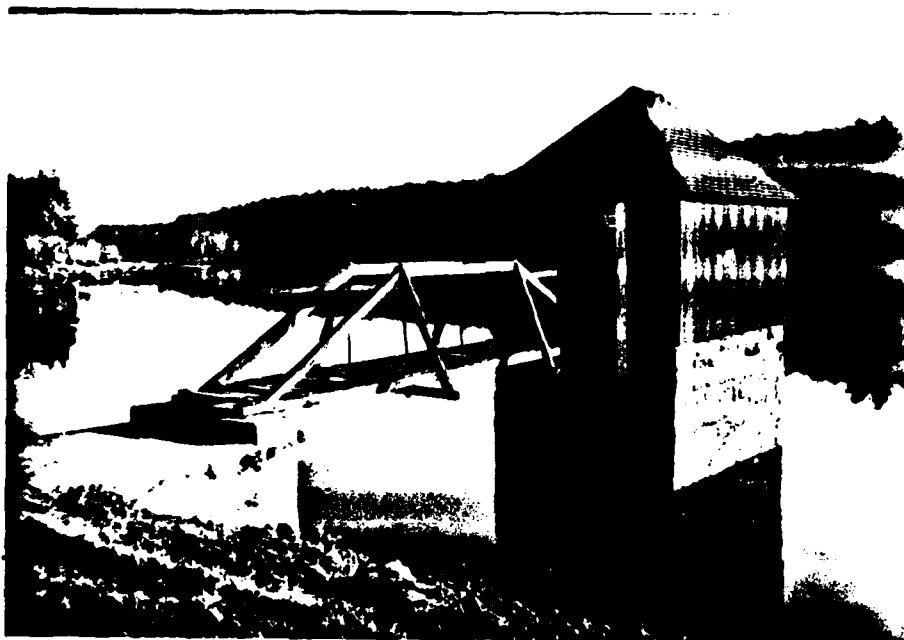
The control mechanism for the inlet gates to the wet well of the gatehouse structure appeared to be in good working order. Flashboards are used to increase storage by raising the effective spillway crest. The service bridge leading to the gate structure needs painting but otherwise appeared to be in good condition.

2. Outlet Works. The outlet works is located on the upstream slope of the dam and is a structure with a stone masonry wet well foundation with a timber superstructure which appears to be in good condition (See Photo C-5). The outlet works consist of two sixteen inch diameter cast iron outlet pipes and one 4 inch diameter outlet pipe which are controlled by manually operated vertical sluice gate mechanisms. One of the 16 inch pipes connects to the water treatment facility downstream of the dam while the other pipeline serves as the outlet works conduit, which discharges into a rock channel at the toe of the dam (See Photo C-6, 12). The 4 inch diameter conduit is used as a by-pass during periods of maintenance on the 16 inch diameter supply pipe. The gate mechanisms appear to be in good condition and the outlet conduit is reportedly operated once or twice a year. An additional gate is located on the outlet conduit. This gate appears to be in poor condition, inoperable and permanently fixed in the open position. (See Photo C-7). Trash screens are located at the outlet works in the control tower wet well and are cleaned periodically. No seepage was observed at the emergency outlet pipe.

C-5 GATEHOUSE AND SERVICE BRIDGE

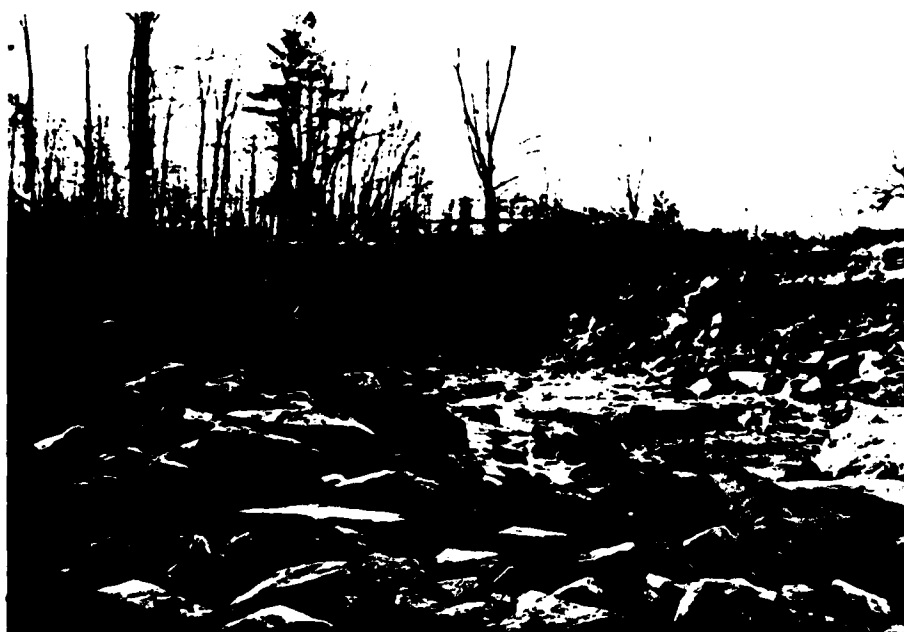
C-8 RESERVOIR BROOK INLET TO RESERVOIR AND APPROACH CHANNEL FOR SPILLWAY.
